TITLE:					copyright BBS Timbers LTD ©		Pipe Penetration Detail	
	NAME	SIGNATURE	DATE	Rev	  27 Kioreroa road PO Box 1407 Whangarei 09 438 9358	DWG NO.	A4	
DRAWN						RC-CW-12		
CHK'D								
APPVD						SCALE:1:10 DNS	SHEET 1 OF 1

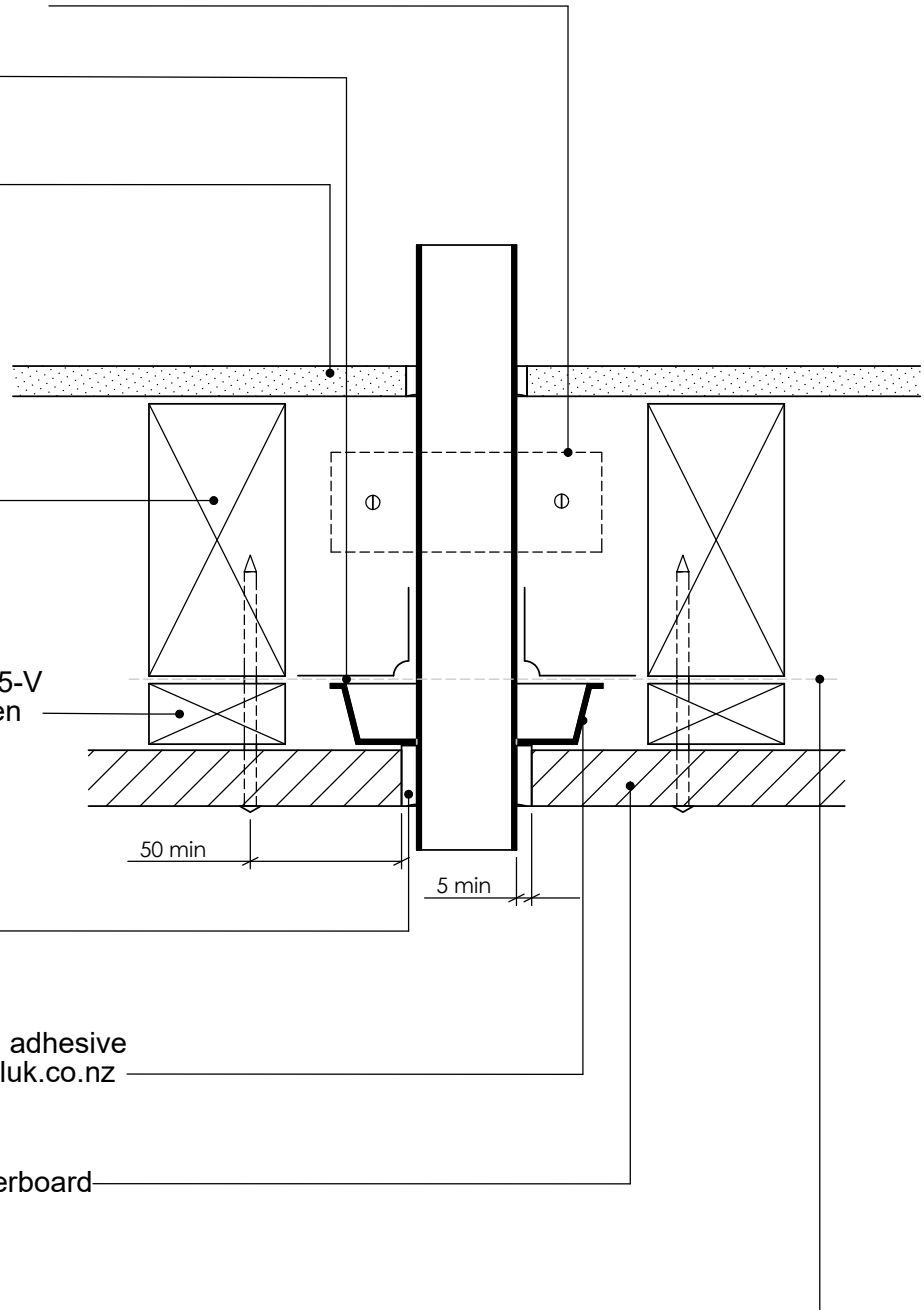
Support pipe with nog
under & a screw fixed strap
over

Flexible flashing tape

Internal wall lining

Framing

CCA treated BBS 20x45-V
H3.2 timber cavity batten

Sealant on backing rod

Vanluk rubber boot with adhesive
collar, refer to www.vanluk.co.nz

BBS Rusticated Weatherboard

Building wrap as per
E2/AS1 Table 23
